Nak 6708 Open Car Floor repairs

March report 2013

Jim Blyde.

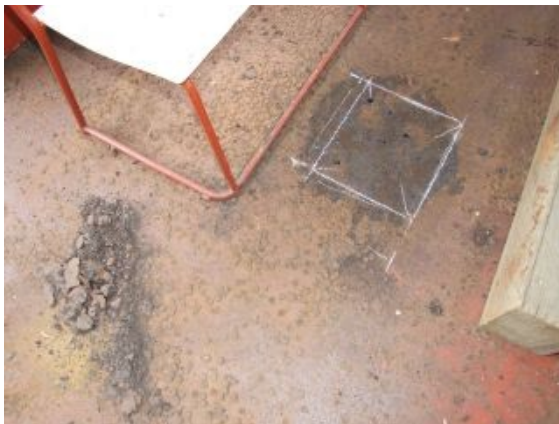
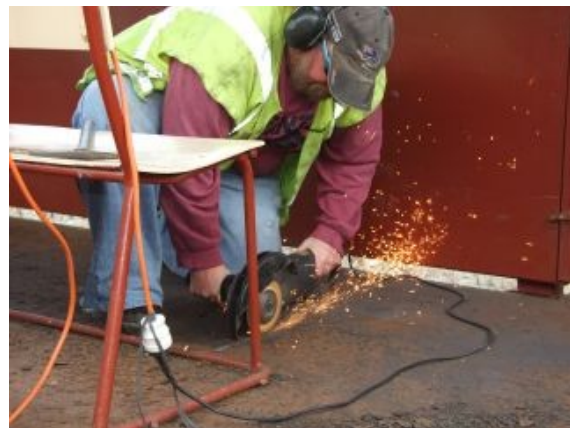
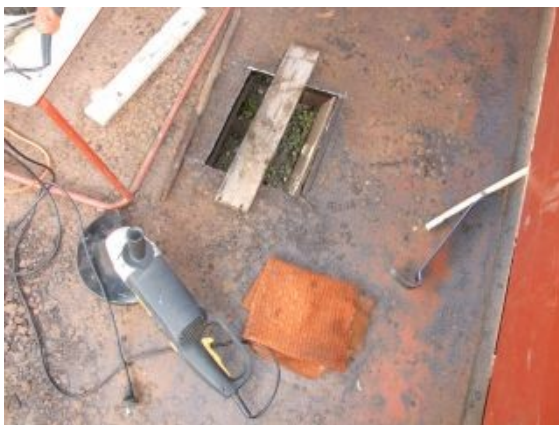
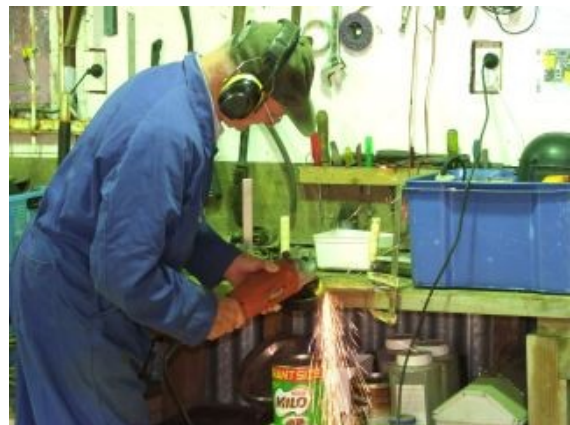
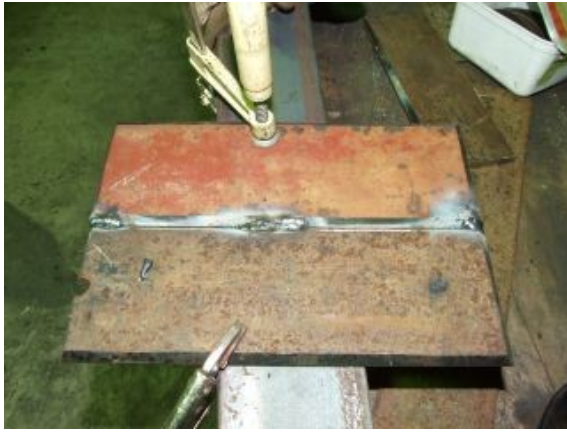
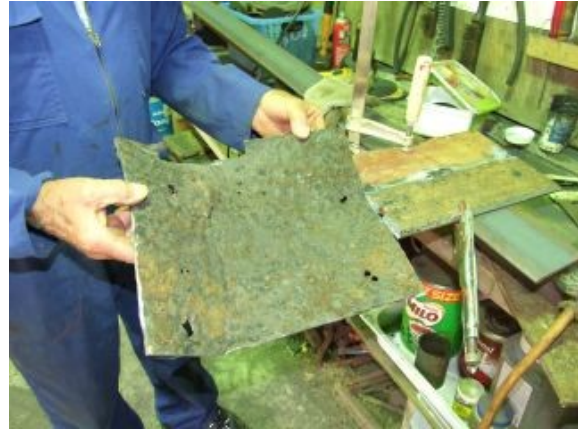
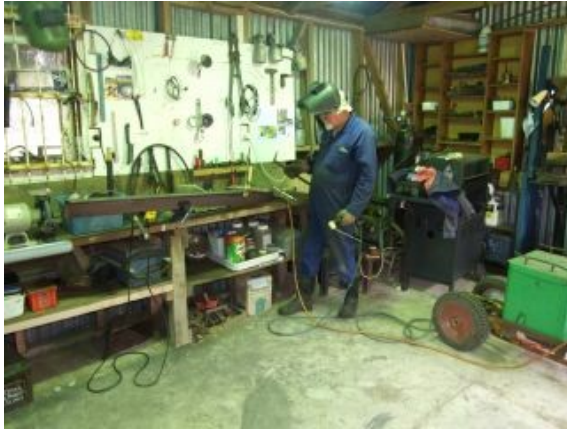
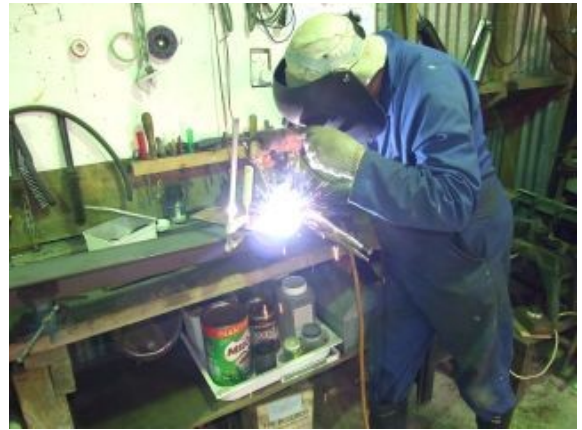
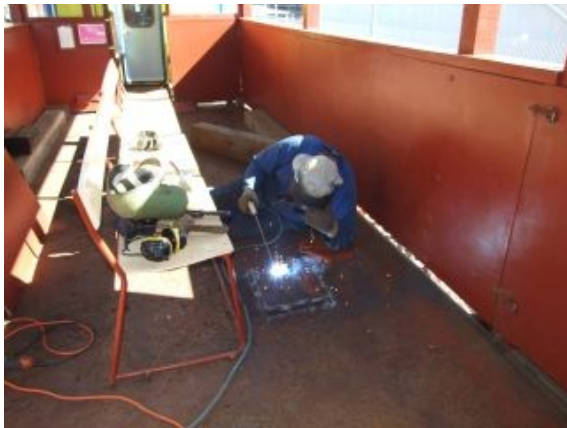
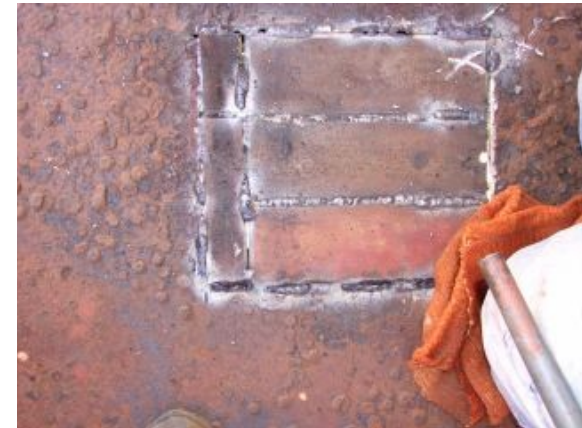
- March 30th
- Between Noel, Carl and myself we measured where the floor had to be repaired, cut material to fit and weld in place after the hole was cut.

- The floor although was ground there was still some difficulty with slag coming to the surface which made the welding difficult.
- The job is not complete yet but is safe to walk on. I did a test by jumping on the replacement plate and obviously, (Well some one has got to say it), I did not fall through the hole.
