JIM BLYDE'S REPORT  
JANUARY 2014

My hours worked so far on Tr 407;-  $42.5 + 5 = 47.5$ ,  $+ 4.5 = 52 + 1.5 = 53.5$

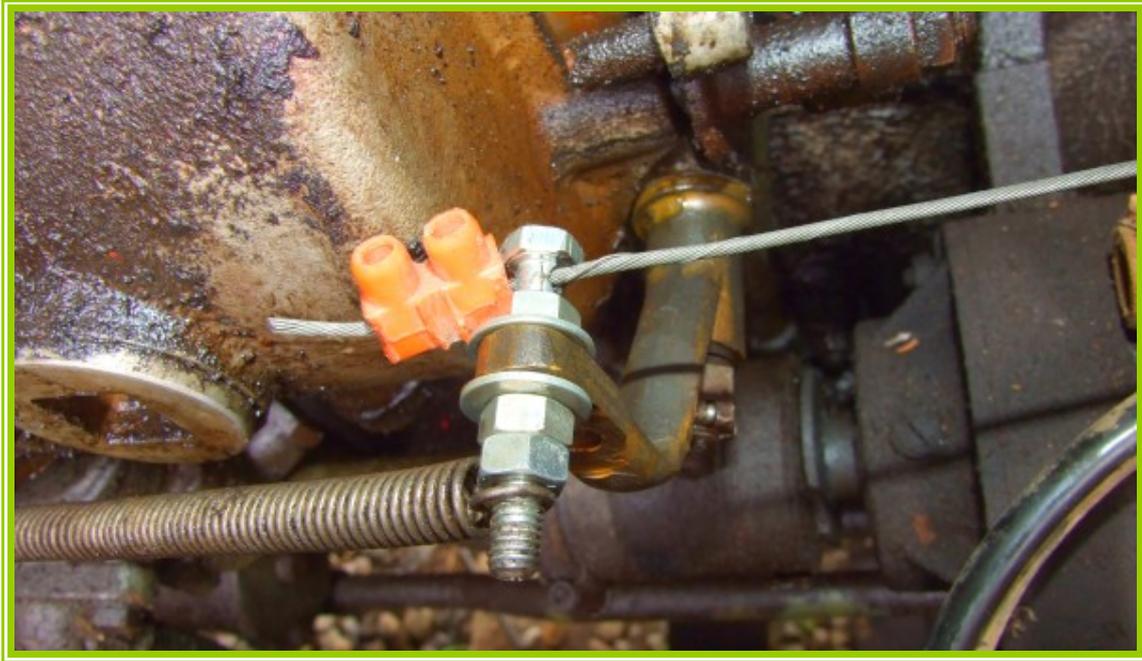
I have finished the repairs to the stop cable with a new bolt with a hole drilled through for the pull cable. As the stop arm had been replaced this was a bit tight against the body of the pump, which was duly slacked off a little bit. The stop cable is working quite well now.

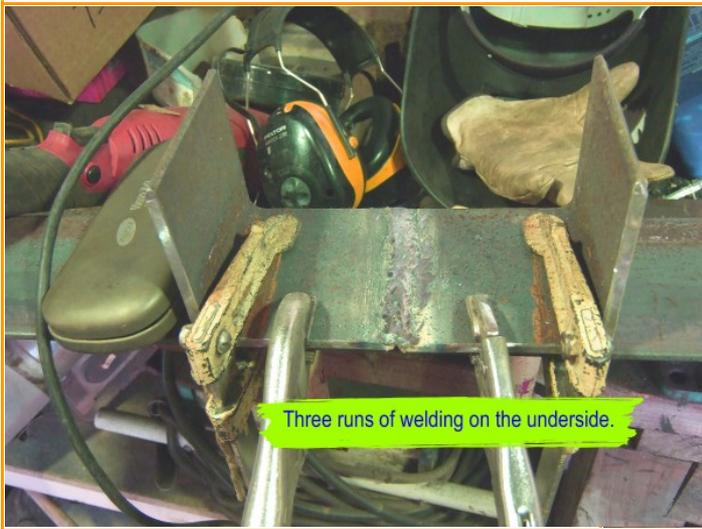
Between Denyse and myself I think we did fairly well.

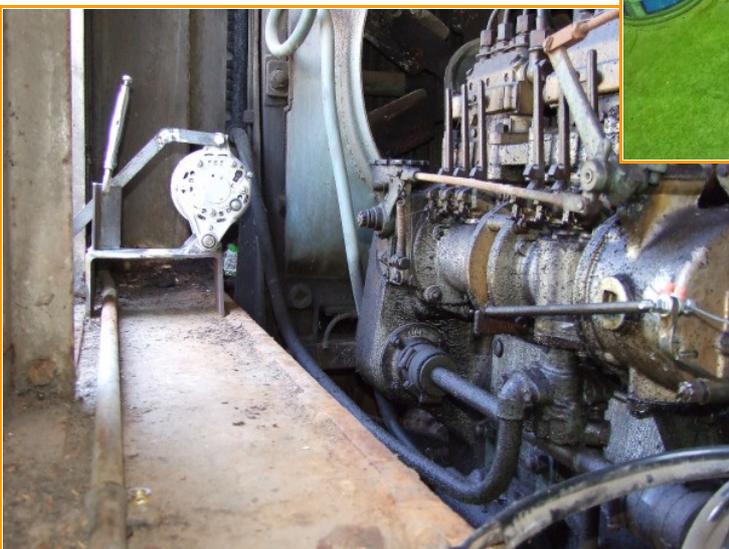
Just about completed. Slotting yet to be done

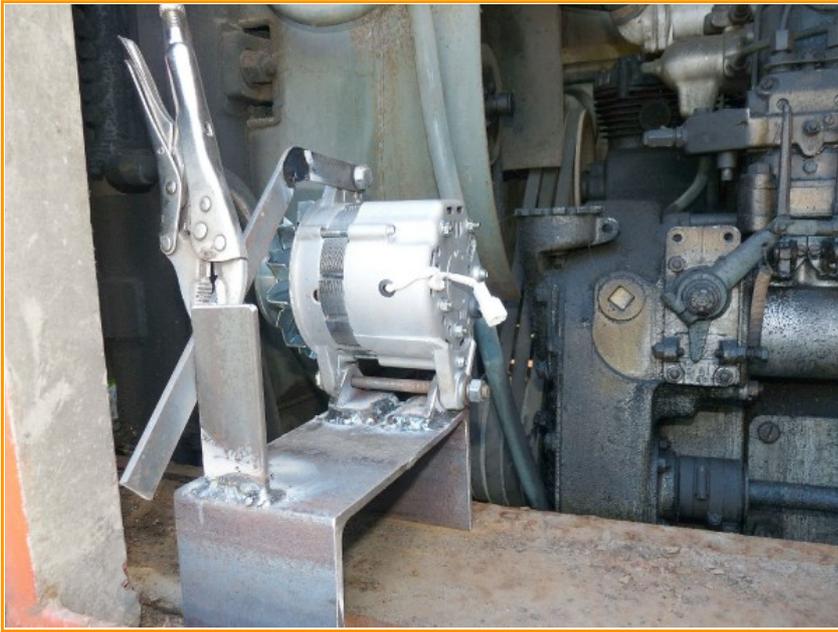
The fan shroud will have to cut out some what to allow for the “V” belt. This will be off the crankshaft and fan pulleys.

The mount will be welded to the frame.
