JIM BLYDE'S REPORT

MARCH 2014

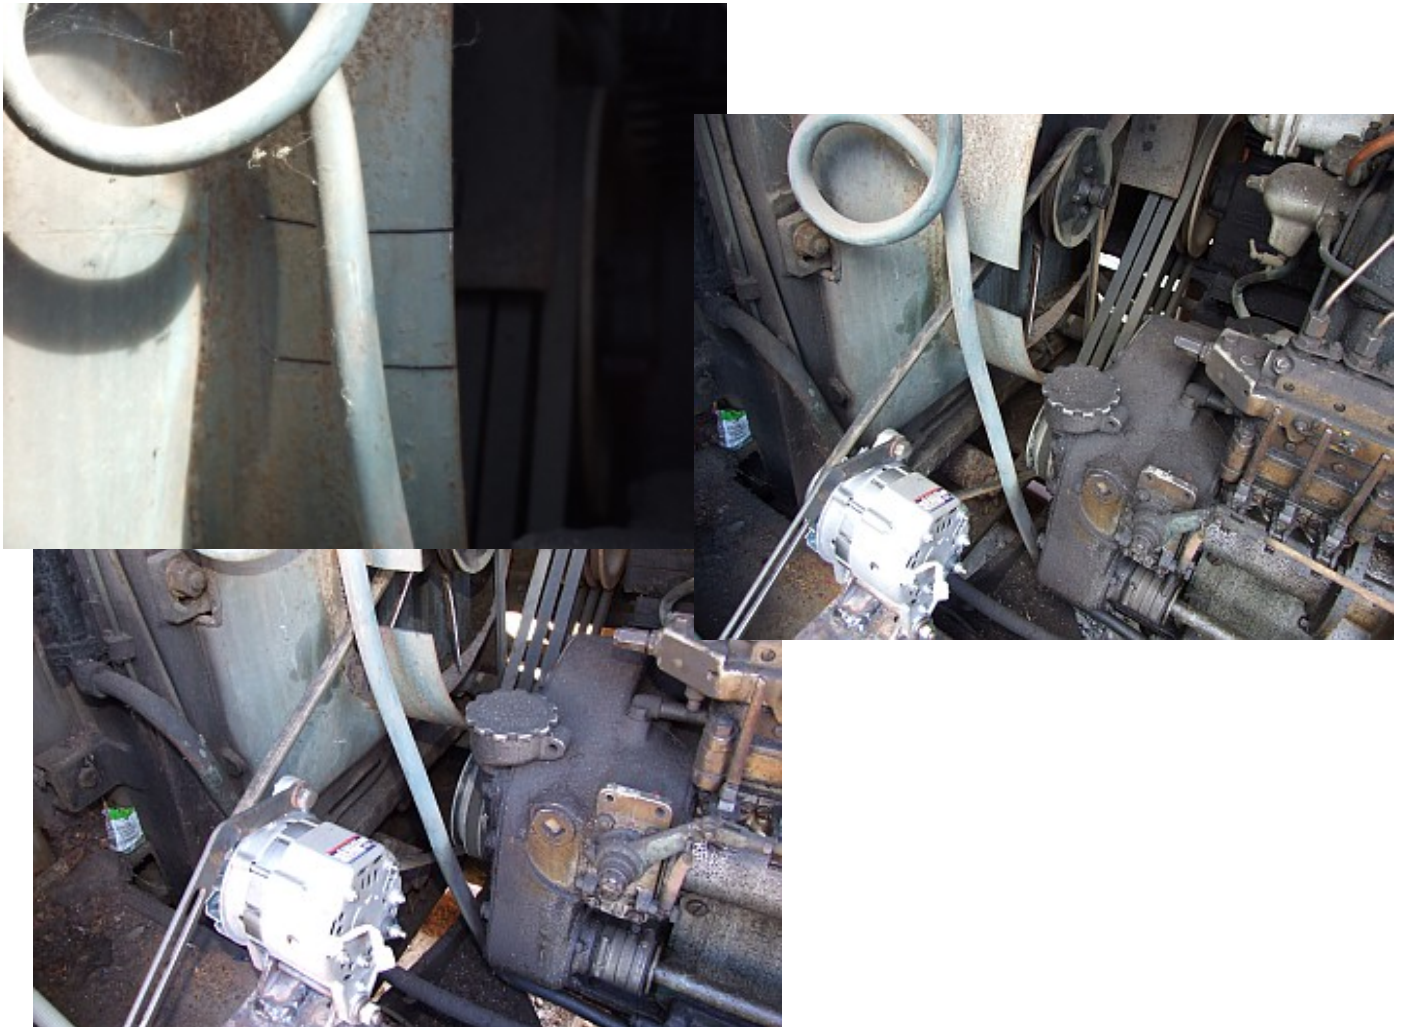
The alternator is site on board after some extra support welded under the bracket. In turn this is also welded to the frame.

Noel assisted with cutting a slot to allow the "V" belt through the radiator fan shroud with a jig saw braking couple of blades in the process. Then he started to drill on the horizontal so that the slot could be completed.

After sitting the line for the "V" belt the bracket was welded to the frame. Once all was completed I gave the engine a turn over, once established that all was good, and gave the engine a quick run. All is looking good.

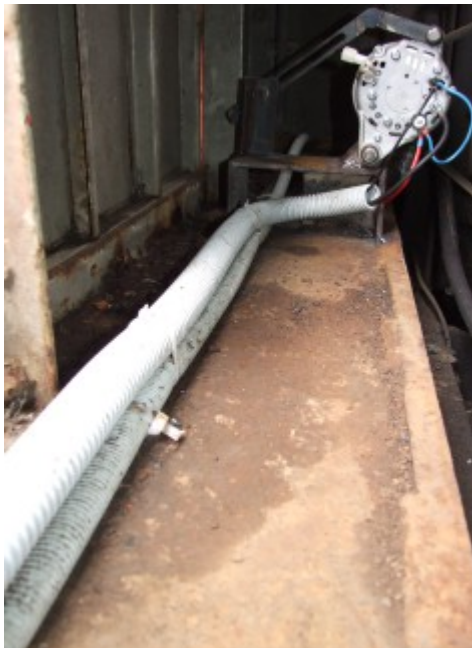
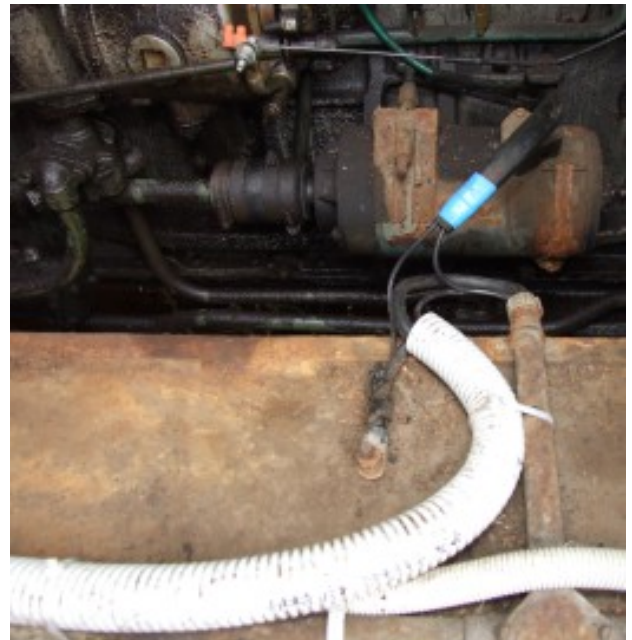
I started to tidy the wiring on the alternator and for the oil pressure switch. Running the alternator wire through some 25mm conduit which is tied to other conduit in place.

While trying the lights and the charging this indicator switch burnt out. This was replaced and the ditch lights are working again working.

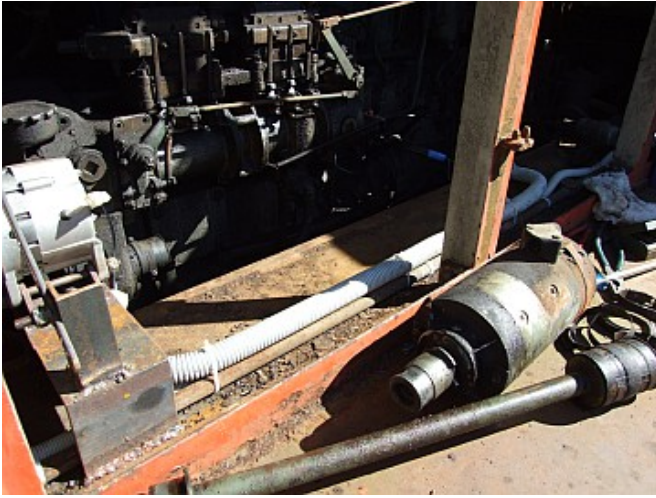
I have removed the shaft and generator which are tagged and stored in shed N°6. The bracket/clamp which held the generator is still on the engine.
